SAFETY ALERT – NEAR MISS

Star Pickets Installed within Eglinton Village Energy (EVE) Power Cable Alignment

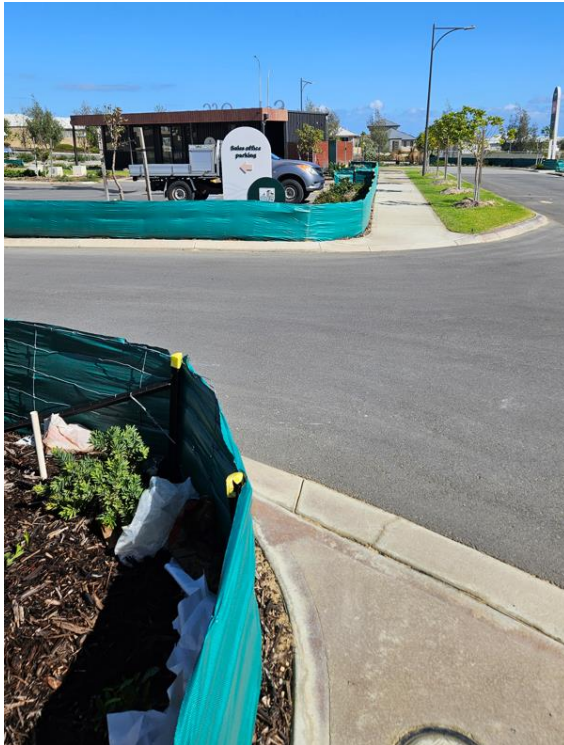
Upon inspection, it was found that a landscaping contractor had installed a row of steel star pickets parallel to the footpath, outside of the lot boundary and within the road reserve 0-500mm cable alignment.

Star pickets installed along footpath within EVE power cable alignment.

- Ensure you complete Before You Dig Australia (BYDA) requests prior to doing any works that may impact underground assets.
- Pothole to confirm location of underground assets.
- Communicate this Safety Alert at prestart / toolbox meetings to your employees and share with all other relevant contractors / stakeholders.

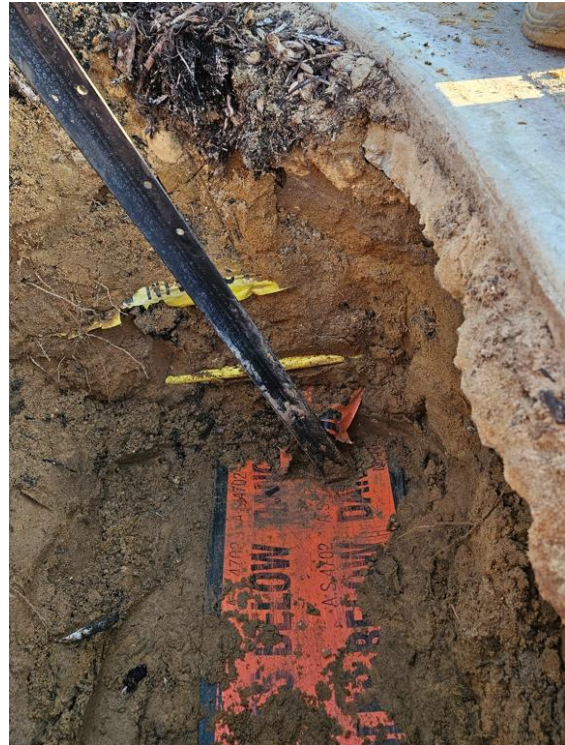
Multiple steel star pickets were found to have been driven through the cable marker tape and cable slab. The steel star pickets have impacted the cable in multiple locations, requiring significant remediation works.

1800mm star picket driven through cable slab. Star picket also narrowly missed the gas service.

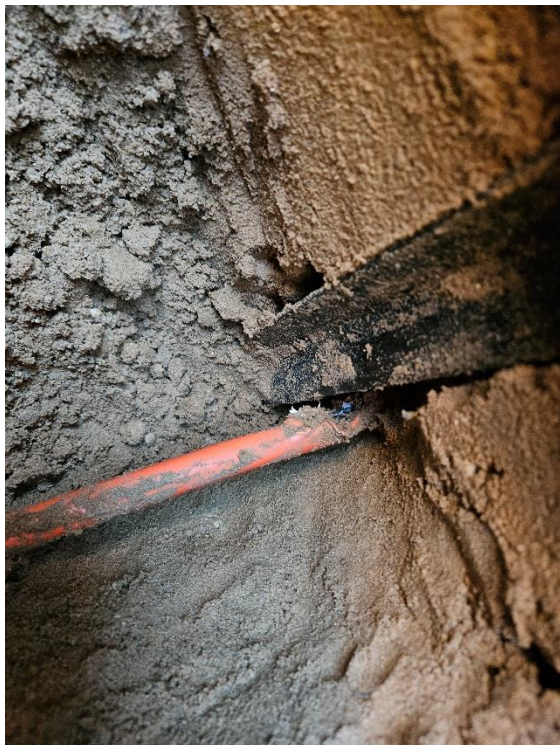
Cable slab removed showing star picket impact with streetlight cable.

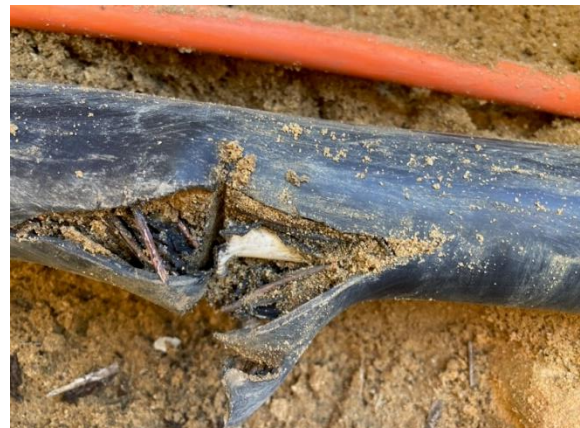
Our technician narrowed down the fault to a section of cable in front of the Eglinton Village Sales Office on Coolum Rd. During his investigation to identify the fault, he attempted to remove a 1800mm star picket and received a mild electric shock.

Damaged section of LV mains cable which had been impacted by another star picket causing the power outage.

- To excavate impacted assets and conduct repairs to damaged cables as required.
